A New Spin on Wax Management: The Centrifuge and Hearing Aids

by Ed Desporte, MS, Roger Juneau, BSME; and Gregory Siegle

Cerumen-related breakdowns and loss of performance in hearing aids have always been challenges for consumers, dispensers, and manufacturers. A new system uses centrifugal force to spin out the wax.

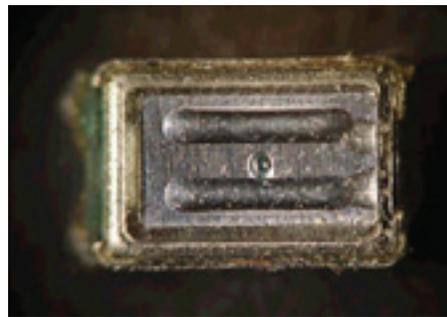
FIGURE 1. Microscopic top view of new receiver diaphragm.

The ear-worn instrument receiver may also become saturated with cerumen over time as a result of the vaporization⁴ and capillary action of liquid cerumen (Figures 1 and 2). The receiver itself is electrically charged, drawing atomized cerumen into all areas of the receiver by the charged, sound-generating coil.

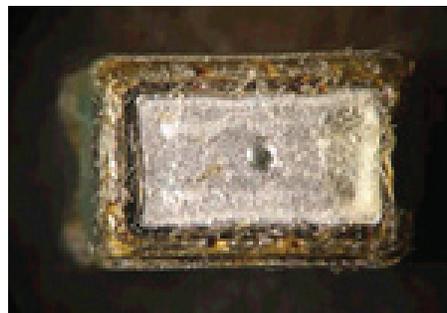
FIGURE 2. Microscopic top view of deteriorated receiver diaphragm suspension that has been invaded by cerumen.

The resulting added mass of cerumen on the receiver diaphragm causes low-output distortion and loss of high-frequency response. A more insidious process occurs as the acidic compounds within the cerumen slowly deteriorate the diaphragm suspension, resulting in receiver failure.

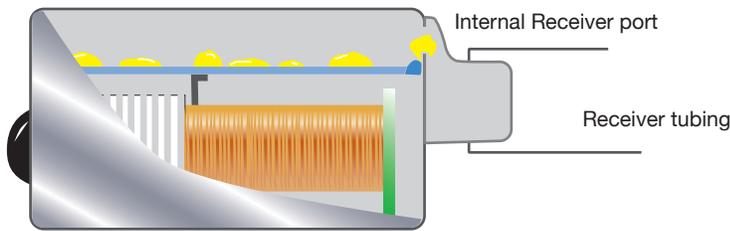
FIGURE 3 Cross-sectional illustration of wax accumulation on diaphragm and internal receiver port.

The receiver further acts as a heat sink. During the heating cycle caused by the warm ear and the heat generated due to electrical operation, it is likely that a “creep factor” causes the wax to flow into the receiver (Figure 3). The cooling cycle, which occurs during the “off” mode, facilitates congealing the liquid cerumen within the receiver.

While in wide use in the hearing industry today, none of these systems has performed with optimum results. All have, to one degree or another, addressed the accumulation of cerumen impacting receiver tubing. None, however, has addressed cerumen buildup within the receivers themselves (Figure 3).

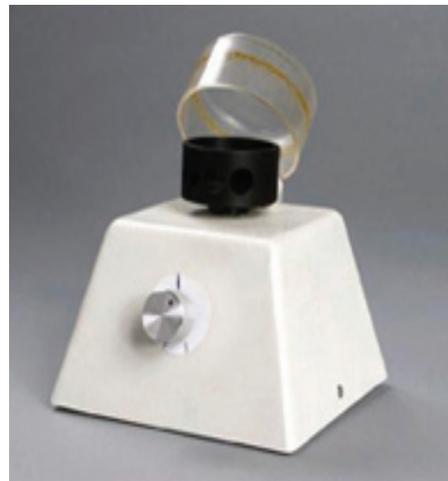
FIGURE 4 Fist prototype of centrifuge wax remover with hub rotor and ring of expelled wax from numerous tests.

To test the concept, a number of in-house prototypes were developed (Figure 4). These were consigned to the instrument repair department. The goal of this investigation was twofold: 1) Would the devices withstand hours of use on a daily basis? and 2) Would the utilization of centrifugal force be effective in returning “dead” or weakly/intermittently performing instruments to performance specifications?

clinical equipment. The prototype, while totally functional, was bulky, heavy, and essentially shop-built. The safety lid on the prototype quickly became coated with the debris ejected from the hearing instruments (Figure 4). While this was reaffirmation of the cleaning ability of the SpinDoctor, it would not have been an attractive or hygienic feature for the office.

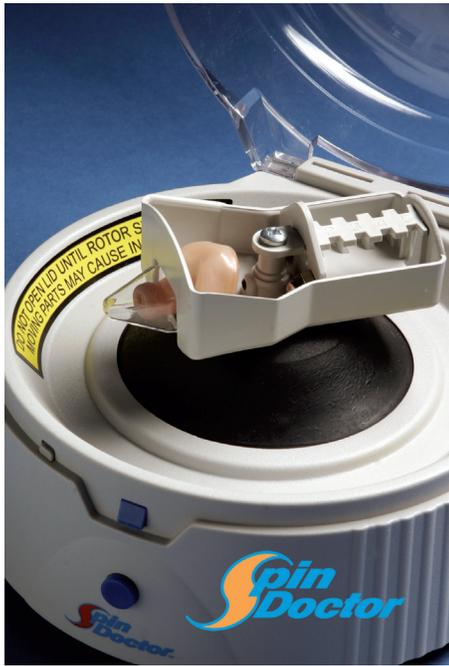
FIGURE 5 Final SpinDoctor Centrifuge with typical ITE seated in adjustable rotor

To resolve hygiene issues and provide a quick and easy system for mounting a hearing instrument to the rotor, a unique rotor collection system was designed (Figure 5). A drum-style rotor was first developed, but required a collection of counterbalances that varied in weight when cleaning a single instrument. Wax containment was still an issue. A revision of the rotor design featured an adjustable counterbalance to accommodate instruments ranging in size and weight from mini-CIC to full-shell ITEs. Wax containment was resolved by developing a clear, high-impact plastic “nose cone” into which the tip of a hearing instrument would be placed.
